**BRUNEL SWIVEL BRIDGE, BRISTOL**

**Avon Industrial Buildings Trust**

**Inspection of Bridge Superstructure**

**January 2016**

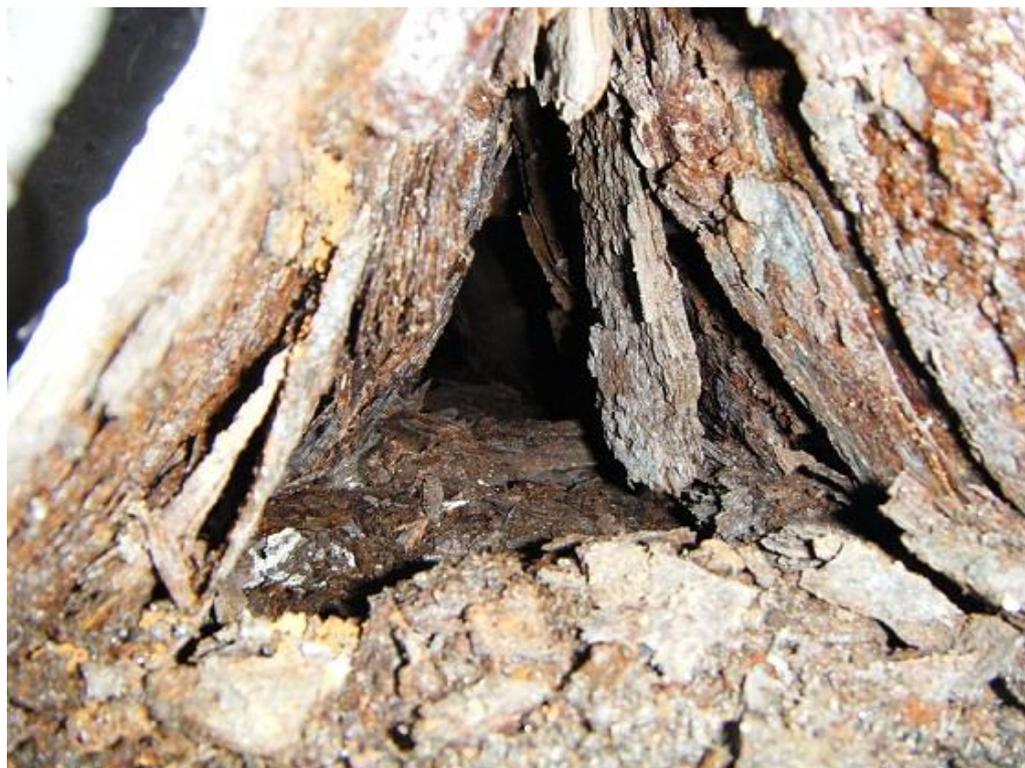
3.1.16 The top segments of the bottom flange are in variable condition. Signs of corrosion along some lengths of the edge beam indicate these areas to be in poor condition. The corrosion damage appears to be due to corrosion of the (relatively thin) plates from the inside surface outwards rather than from the external visible surface. The original drawings for the bridge indicate that the plate thickness was intended to be

3.1.18 Three sections of the top segments of the bottom flange were taken off for inspection by removing existing plates, which had been welded into position as part of a previous repair regime. Two of these plate areas were on the outer side of the south edge beam where trial repairs were completed. The other area was on the inner side of the north edge beam. Very significant corrosion was found at some but not all of the exposed sections of the top segments. The worst areas of corrosion are probably co-incident with areas where the build-up of corrosion products has allowed moisture to become trapped within the section. *Plates 1 and 2* show very significant corrosion and insignificant corrosion (to the upper segments) respectively.

**Plate 1 – Very significant corrosion within closed bottom section**

3.1.20 Significant amounts of repair work will be required to these segments of the edge beams as part of the bridge renovation. In the first place, there are significant areas where replacement of plate is required because corrosion has removed the entire section thickness or a very substantial proportion of that thickness. Secondly, there are areas where previous repairs have been carried out and these repairs have also corroded. Additionally, measures will be needed to protect the internal portions of the triangular segment from future corrosion, bearing in mind the lack of maintenance access to the area. The external coating to the flange segments plates will need to be entirely refurbished as part of the renovation process.

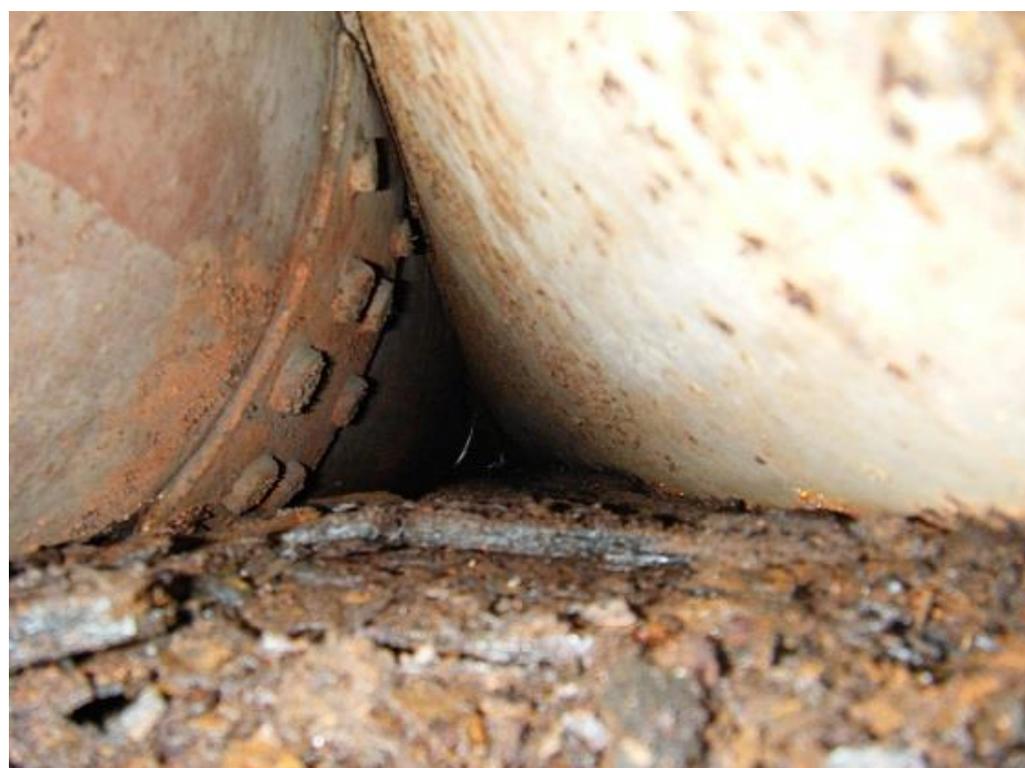
**Plate 2 - Slight or insignificant corrosion to upper segments within closed bottom section**

3.1.19 However, it can be seen that corrosion has taken place at the crevice where the upper segments meet the base plate and this is reflected in observations on the outer surface.

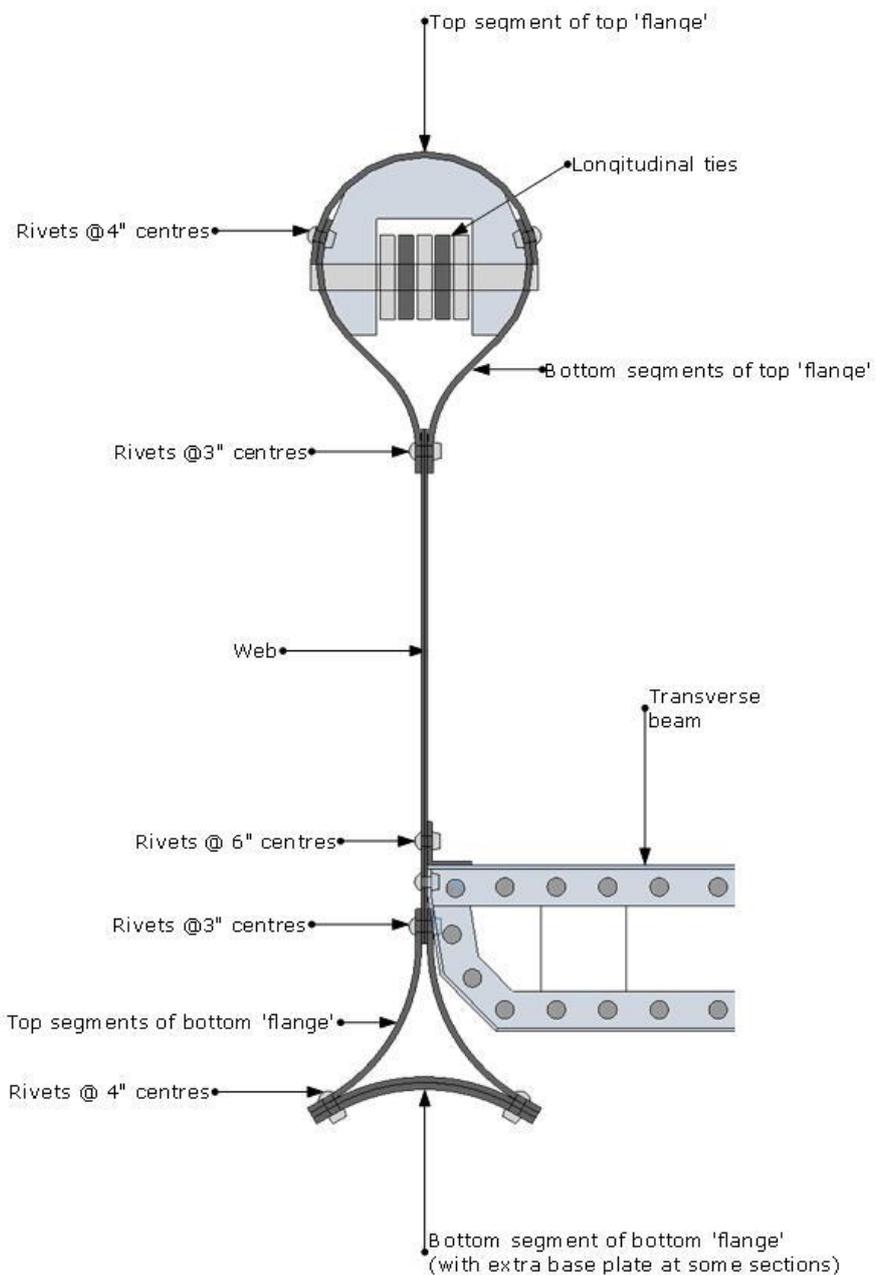
Figure 1 - Typical Section on Edge Beam

- 2.1.6 The cross section of the edge beam is constructed, typically, as shown in *Figure 1*. Individual plates vary in length (along the bridge span) from about 1m to a maximum of about 6m.

- 2.1.7 As can be seen from *Figure 1*, the typical section comprises a curved top plate and two curved side plates forming the top 'flange' of the beam. The web is a single flat plate. The bottom 'flange' comprises two curved side plates and a curved base plate. In some areas (the sections adjacent to the turntable support), the curved base plate is a double plate. The horizontal joints between adjacent plates making up the section are riveted.

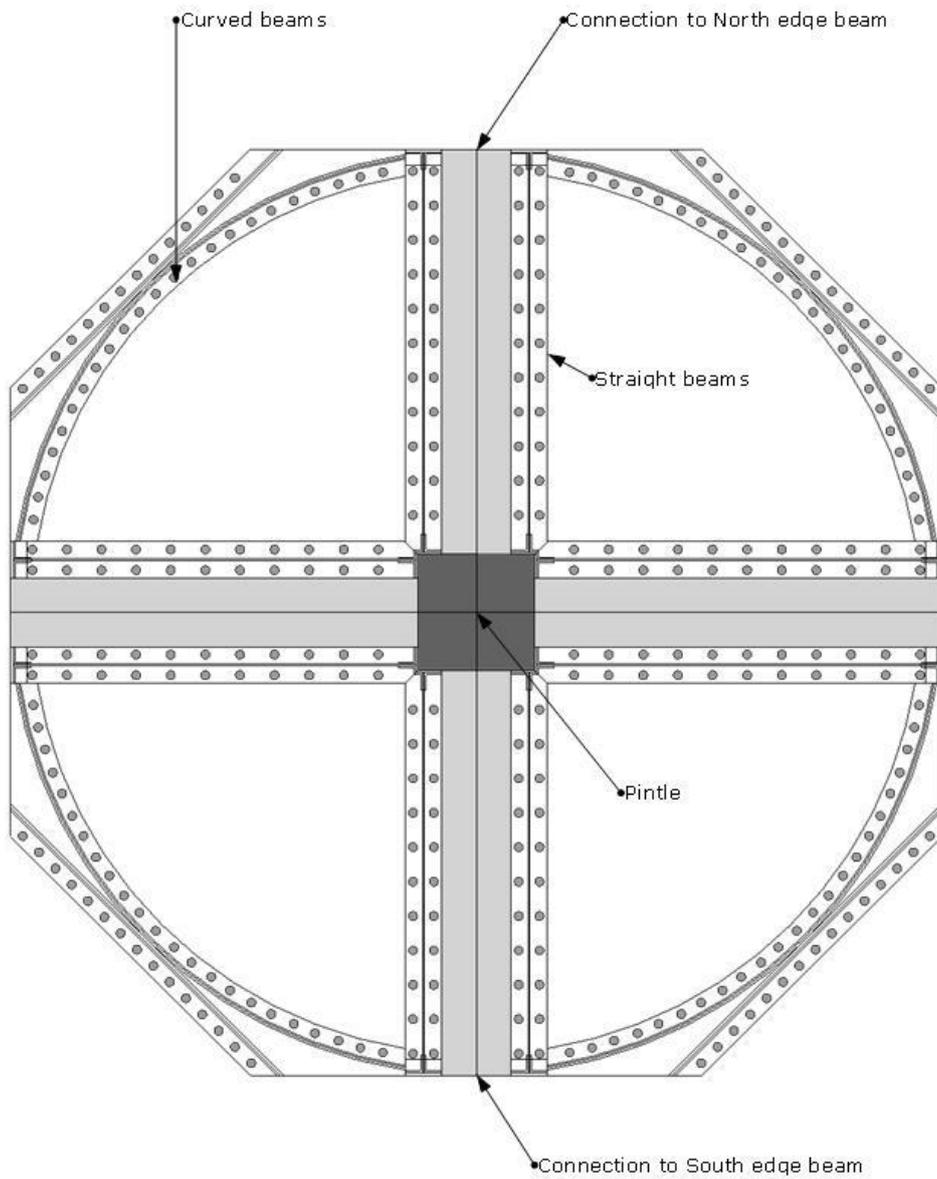
**Figure 2 - Plan on Turntable beams**

2.1.14 The turntable assembly comprises a number of beams as shown in plan in *Figure 2*.

2.1.15 Eight straight beams are connected to the pintle; two beams are connected from the pintle casting to the north edge beam; two beams are connected from the pintle to the south edge beam; and four beams are connected from the pintle to one of the (non-typical) transverse beams, two in each of two directions east to west and west to east.
